Manhole Inspection Summary

Manhole # S43II_005MH

Insp Date: **10/23/07 11:26 AM**

Location Address: **1540 BROADWAY**

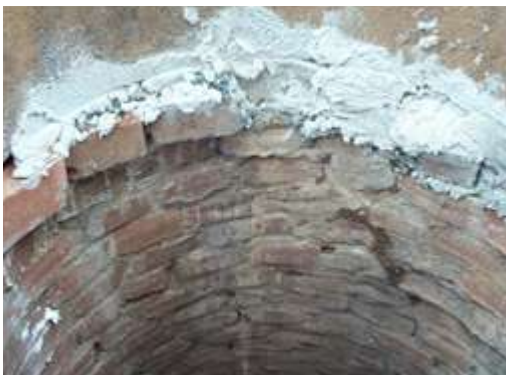
Defect 2

Condition: ☐ Sound ☒ **Cracked** ☐ Root Intrusion ☒ **Loose Brick** ☐ Deteriorated

Cracked chimney and loose bricks

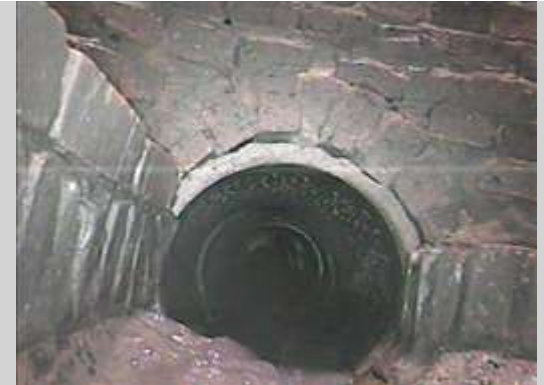
12 O'Clock Outflow

Pipe Height: **8.4** (in.) Rod and Bar
Pipe Material: **Clay** ☐ Pipe Lined
Invert Depth: **15.37** (ft.) Flow Characteristics: **Fast**
Deposits: ☒ None ☐ Mud ☐ Sludge ☐ Debris ☐ Grease
Silt Depth: (in.) Deposits Extent:
Infiltration: **None** Pipe Seal Cond: **Cracked**
